## AZIPOD PROPELLER BLADE CAVITATION OBSERVATIONS DURING SHIP MANEUVERING

A.V.Pustoshny, S.V.Kaprantsev

Krylov Shipbuilding Research Institute, Russia, St.Petersburg

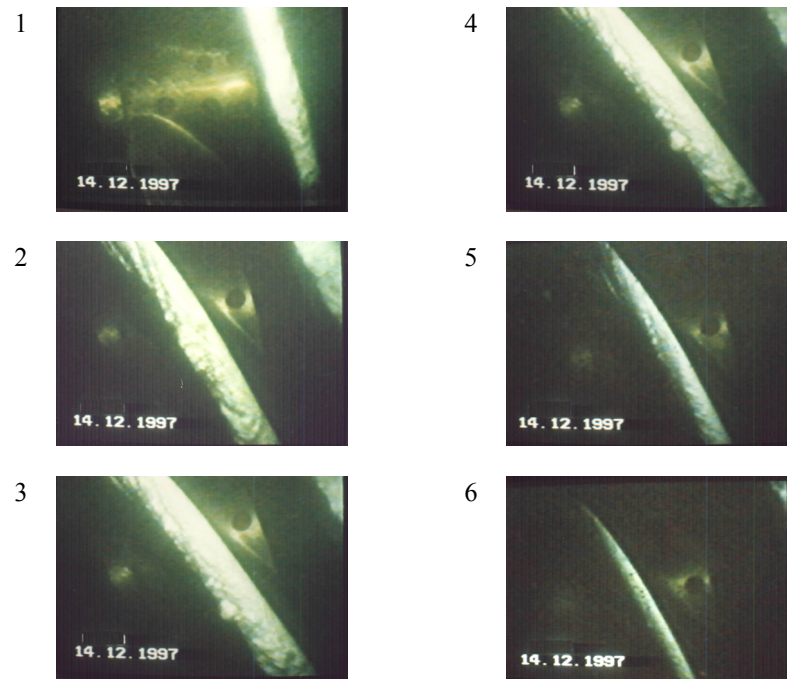
**Fig.2 Cavitation growth during ship acceleration**

Analyzing cavitation phenomena associated with the ship's acceleration from zero speed one can see that the principal and the only kind of cavitation was a very thick suction-side tip vortex. This vortex was significantly thicker than at the full speed of the ship. One could clearly see the "tail" of the vortex trailing from the previous blade. This indicates to a much wider blade angle range occupied by the vortex. The higher became the ship speed, the less was the thickness of the vortex (Fig.2) and eventually it approached the vortex thickness associated with full-speed-ahead conditions.

One may notice strong cavitation of the tip vortex, which becomes thinner with higher ship speeds

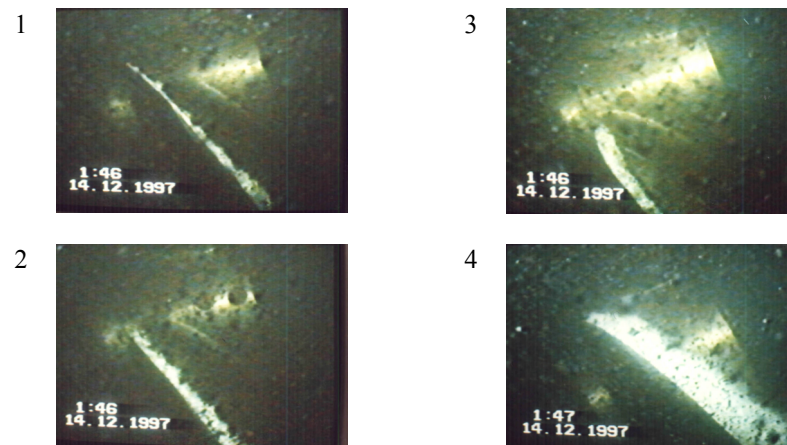
**Fig.3 Crash-stop. The initial phase**

- At the initial phase the ship has a certain forward speed and the propeller revolutions are decreasing. This is accompanied by pressure-side cavitation growing up to a certain moment (Fig.3). Due to the unsteady pattern of the flow in way of the propeller hub, from time to time there appeared a chaotic portion of the vortex stretching along the hub. Those pieces of longitudinal vortices were of about the same length as the hub.

At the initial phase of the stop-crash maneuver one may see a very rapid growth in sheet cavitation along the pressure-side edge of the blade

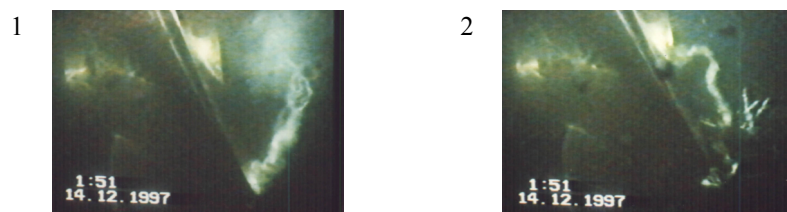
**Fig.4 Crash-stop. Changing over to astern sailing**

- At low ship speeds there were truly fantastic patterns of highly skewed unsteady vortices (Fig.4). It may be assumed that what the observers could see were "fragments" of unsteady vortices generated near the pod due to crash stopping.

At the instant when the ship starts moving astern the change in the propeller rotation direction is associated with flow separation at the blades

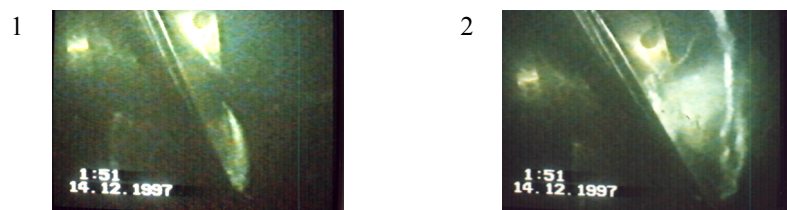
**Fig. 5 Crash-stop (continued)**

- While the ship accelerated astern, there were pronounced pressure-side cavitation vortices stretching along a trajectory going far away from the blade (Fig.5). Chances to observe this cavitation pattern were very limited because of the solid sheet of air bubbles that rapidly covered the windows as soon as the ship moved astern.

When the ship starts moving astern (the left photo) one may see cavitation on the trailing edge, which under such conditions actually becomes the leading edge. The right photos demonstrate the separating vortex

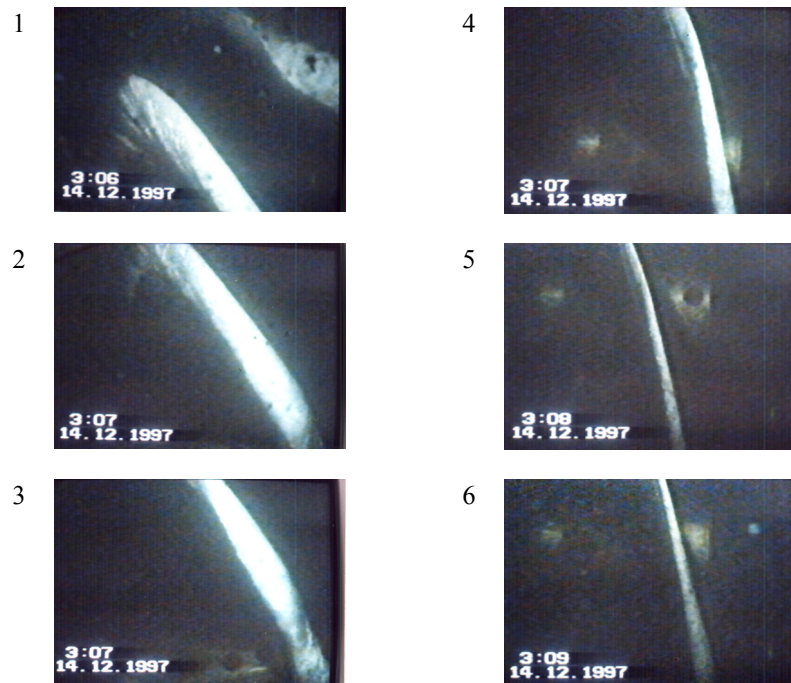
**Fig.8 Cavitation scenario observed with the AZIPOD turning towards the centerline from the “hard over helm” position**

- (3) A fairly consistent picture of the cavitation scenario can be derived from the analysis of transient processes, i.e. those associated with the turns of the pod. When the AZIPOD is turning downwards (from side to centerline), one can clearly see some residues of sheet cavitation that covers the whole upper portion of the blade starting at about 0.9 radius like has been observed on the turning circle.

This series of photographs shows the cavitation scenario observed while the AZIPOD was turning. At greater incidence angles one could see sheet cavitation at blade edges and tip vortices. With the decrease in the pod angle there remains only the tip vortex

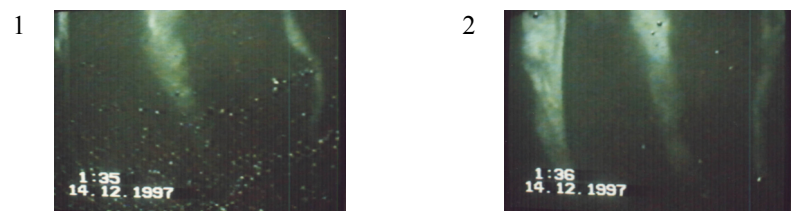
**Fig.9 Turning circle with the AZIPOD set 35° to the centerline**

When the ship circled with the AZIPOD turned to the centerline, the propeller was completely out of sight. Nevertheless, it was possible to get some videos of the cavitation pattern on the turn with the pod at  $35^\circ$  to the centerline. The pictures clearly show 3 "tails" of tip vortexes from starting from different and just entering the camera field of view. This indicates that in the subject case the cavitation region might have been wider than  $180^\circ$  and the blades were cavitating throughout the greater part of their paths (Fig.9). As suggested by English (1998), such a pattern of broken vortices may provoke an increase in high-harmonic pressure pulses.

In these photos one may notice tail portions of three breaking vortices trailing from different blades

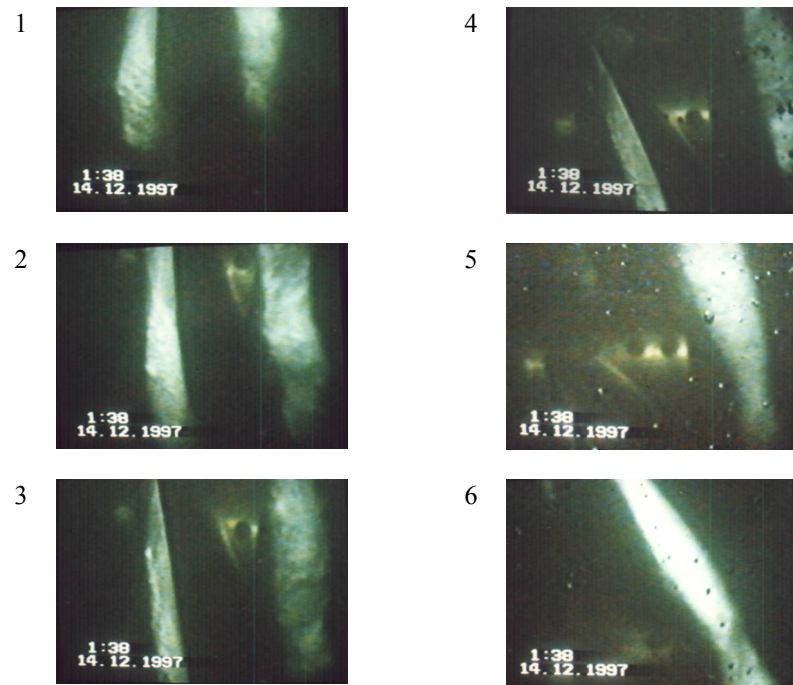
**Fig.10 AZIPOD turning from the 35° position towards the zero incidence angle**

Cavitation scenarios observed when the pod was turning away from the centerline (Figs.9, 10) tended to be more sophisticated. Obviously, while the AZIPOD was set along the centerline, the dominating role belonged to the suction-side tip vortex. When the pod was turned port or starboard to about  $10\sim40^\circ$ , the vortex moved from the suction side to the pressure one and then returned to the suction side where it was accompanied by the above-described sheet cavitation. Unfortunately, photographs fail to show the instant the cavitation changed sides but the observers could see the blade tip sticking out of a vortex cloud enveloping it from both sides. Apparently, such rapid changes in the forms of cavitation are associated with the rotation of the pod but to get a better understanding of the process it would be necessary to carefully analyze relations among wake-induced propeller inflow velocities, instantaneous propeller inflow angles considering the drift angle, propeller revolutions, etc.

When the blade enters the field of view one can see that its tip portion is enveloped by sheet cavitation transforming into a tip vortex (the lower left photo)
